## Analyses of LiNbO<sub>3</sub> wafer surface etched by ECR plasma of CHF<sub>3</sub> & CF<sub>4</sub>

Naoki Mitsugi, Kaori Shima, Masumi Ishizuka and Hirotohi Nagata

New Technology Research Laboratories, Sumitomo Osaka Cement Co., Ltd.,  
585 Toyotomi-cho, Funabashi-shi, Chiba 274-8601 Japan

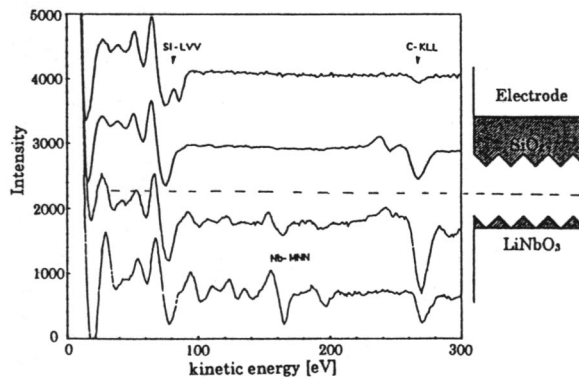
Fig. 2. Result of AES analysis for the failed device, in which the surface electrodes and the  $\text{SiO}_2$  buffer layer peeled off from the etched LN wafer surface.

The thick ground electrodes were peeled off during the cutting process of the LN chips from the wafer. The ground electrodes were formed over the ECR etched LN surface via the  $\text{SiO}_2$  buffer layer. In our experience on thousands of conventional LN modulators made without the ECR etching process, such failure has rarely been observed. Figure 2 shows the AES profiles for surfaces of the peeled electrode and the substrate. The dashed line in the figure denotes the peeled position, and the profiles over and under the dashed line denote the peeled electrode underneath and the remaining substrate surface, respectively. The other two profiles were measured after a few minutes of Ar ion etching of the corresponding surface to exclude the effect of surface contamination. As is seen, the Auger electron peaks come from Nb were detected only from the substrate, indicating that the electrode peeled off at the boundary of the LN and the  $\text{SiO}_2$  buffer layer. In other words, the adhesive strength between the ECR etched LN and the  $\text{SiO}_2$  was weak the chemically induced problem.

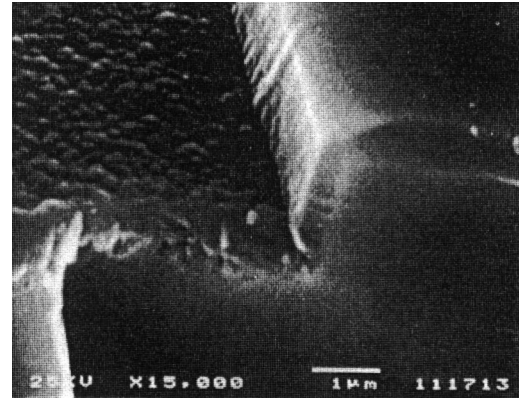
Fig.3. SEM image of the cross-section of the LN wafer with ridge waveguides and the buffer layer. The ridge waveguides were prepared by ECR etching using  $\text{CF}_4$ .

Figure 3 shows a SEM image of a cross section of the ridge waveguide with only the 1.2  $\mu\text{m}$  thick  $\text{SiO}_2$  buffer layer without the electrodes. The boundary between the buffer layer and the LN ridge waveguide

was smooth and the buffer layer and waveguides adhered closely to each other. However, the boundary on the etched LN surface was rough accompanied with small voids, suggesting the inferior adhesion of the buffer layer.

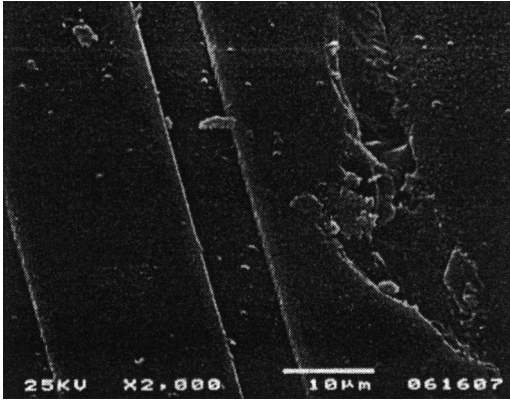
Fig. 4. SEM images of the broken ridge waveguides after the SiO<sub>2</sub> buffer layer deposition process.

In addition to the chemical problems, catastrophic mechanical problem occurred in the fabrication of the ridge waveguide devices. Figure 4 shows the SEM image for the mechanically broken ridges, in which the waveguide was also broken and could not transfer any optical signal. Such failure was found frequently after the buffer layer deposition on the substrates ECR etched by CF<sub>4</sub>. With increasing the buffer layer thickness, the number of broken waveguides increased and the fabrication yield for the devices deteriorated significantly (almost all device chips in the wafer failed due to the break at somewhere in the waveguides).

As a reason for the damaged ridge waveguides, surface stress due to the buffer layer formation was considered. Internal stress of the sputtering-deposited SiO<sub>2</sub> buffer layer on the LN was previously found to be compressive stress and tensile stress for LN surface. On the other hand, growth of a notch line along the ridge waveguides, as shown in Fig. 5, was found for the samples ECR etched by CF<sub>4</sub>. The SEM image of Fig. 5 (a) was observed before the buffer layer deposition. There was possibility that the notches were the origin of the fractured ridge waveguides with the tensile stress on the LN surface being induced by the buffer layer deposition.

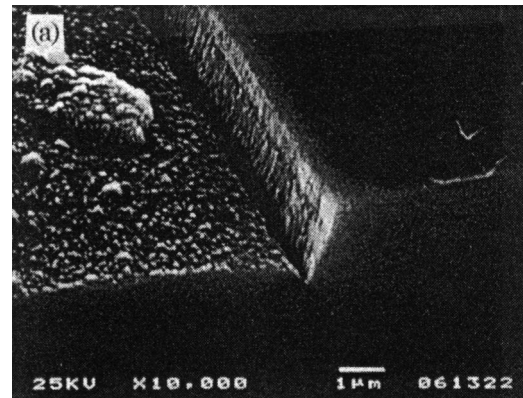
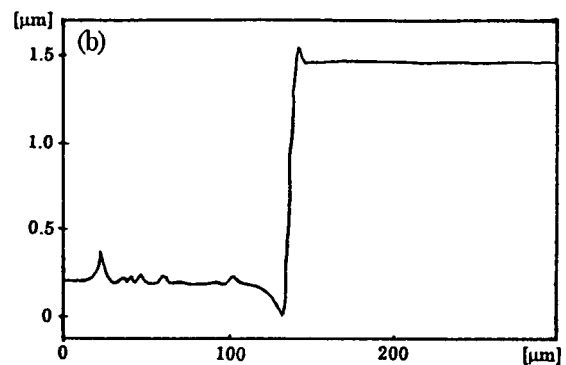
Fig. 5. (a) cross-sectional SEM image of the ridge waveguide prepared by the CF<sub>4</sub> ECR plasma etching, and (b) the corresponding surface profile measured by the stylus method.

Another problem was notches along the ridge waveguide foot formed during the dry etching (see Fig.5). This problem was found to be improved by changing the etching gas from  $\text{CF}_4$  to  $\text{CHF}_3$ , although the reason for the improvement is not known at this time. Figures 8(a) and 8(b) show the SEM image and the surface profile, respectively, of the ECR etched ridge waveguides using  $\text{CHF}_3$ . The ridges with 4 - 5  $\mu\text{m}$  height were successfully fabricated over the 3 in. diam LN wafer without any notches.

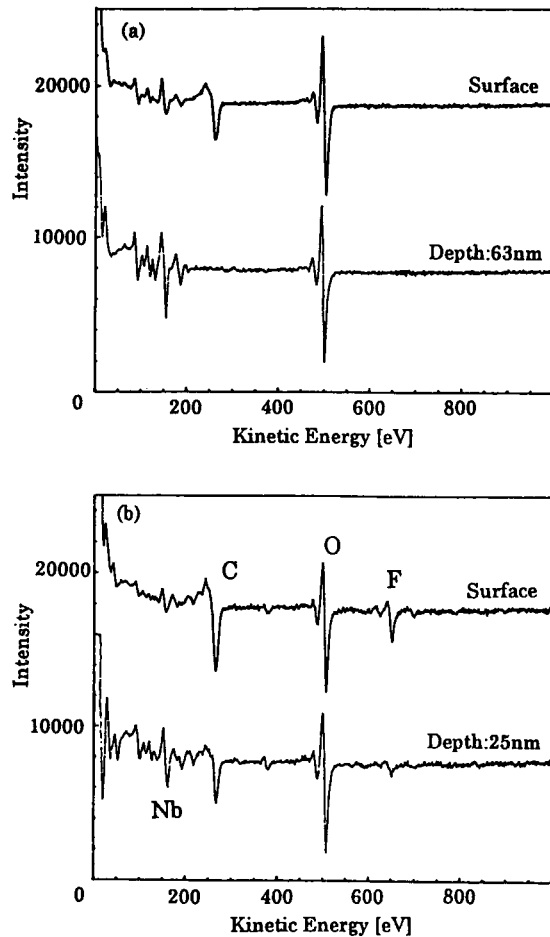
Results of the AES examination of the ECR etched surface, as shown in Figs. 6 (a) for the virgin LN surface and 6 (b) for the etched surface, show significant amounts of fluorine and carbon from the ECR etched surface. These contaminants are thought to deteriorate the adhesive strength of the buffer layer on the etched LN surface. The origin for the contaminants was previously investigated and found to be precipitation of LiF and polymers, possibly due to the etching gases, CHF<sub>3</sub> and CF<sub>4</sub> (9, 10).

Fig. 6. AES measurement results for (a) virgin LN surface and for (b) the ECR etched surface with  $\text{CF}_4$ .

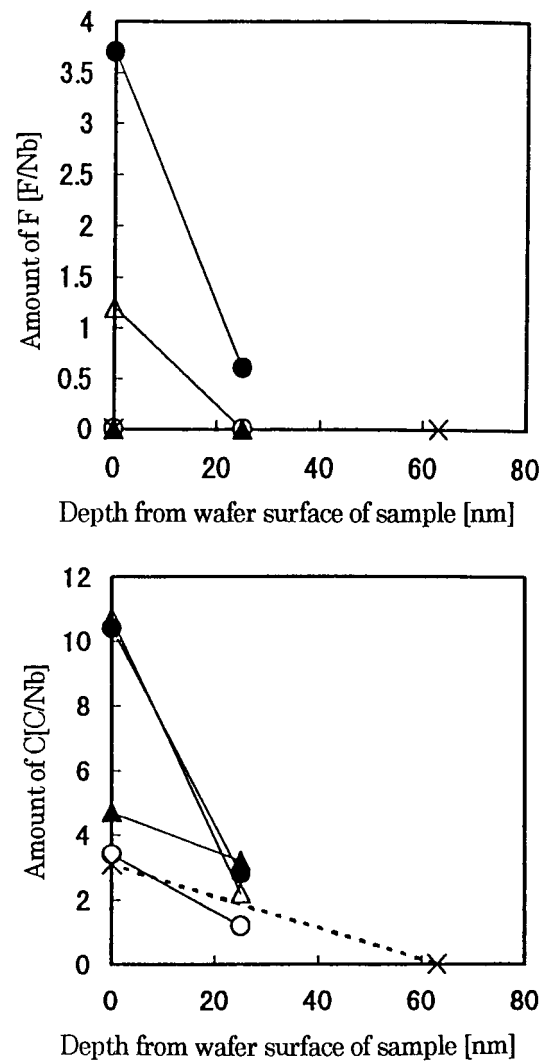
In order to improve buffer layer adhesion, a method to remove surface contaminants was investigated. Three kind of method were attempted here; ① wet etching by dilute HNO<sub>3</sub>, ② O<sub>2</sub> annealing at 600 °C for 1 h, ③ O<sub>2</sub> plasma ashing. After the treatments, the surface of samples was evaluated by AES. Fig. 7 (a) and 7 (b) show the amount of F and C measured

for etched surface. Data of F and C were normalized by Nb peak intensity measured at same samples. As the result, F and C were easily removed by wet etching by dilute  $\text{HNO}_3$  or  $\text{O}_2$  annealing.

Fig. 7. Data of AES. (a) Amount of F measured on surface of samples. (b) Amount of C measured on surface of samples. (●) : after ECR etching, (○) : after wet etching by dilute  $\text{HNO}_3$ , (▲) : after  $\text{O}_2$  annealing, (△) : after  $\text{O}_2$  ashing, (×) : virgin surface)

The ridge waveguide devices were prepared again, adopting process for removing the surface precipitates (especially the  $\text{LiF}$ ) before the buffer layer deposition process. The above described  $\text{O}_2$  annealing at  $600^\circ\text{C}$  and the alternative  $\text{HNO}_3$  etching were attempted. The adhesive strength of the buffer layer was improved and both buffer layer and electrodes were not peeled off, even after machining the wafer.

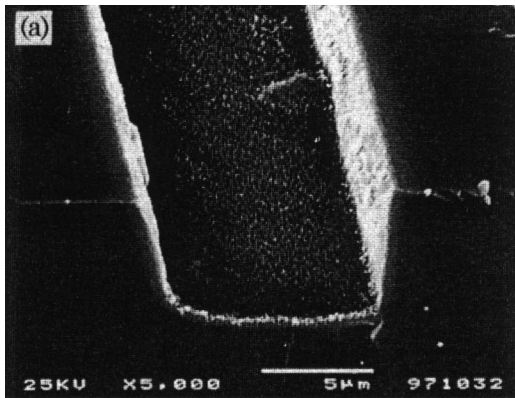
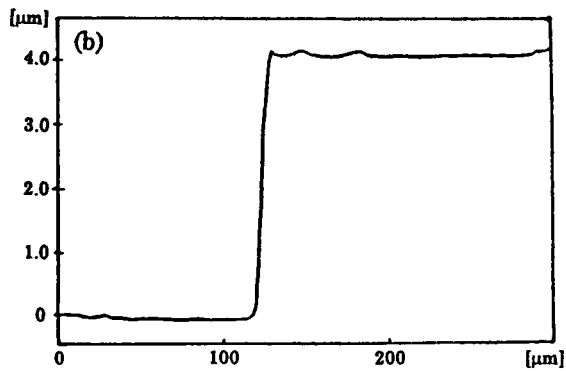
Fig. 8. (a) Cross-sectional SEM image of ridge waveguides prepared by the  $\text{CHF}_3$  ECR plasma etching, and (b) the corresponding surface profile measured by the stylus method.
