## Analyses of LiNbO<sub>3</sub> wafer surface etched by ECR plasma of CHF<sub>3</sub> & CF<sub>4</sub>

Naoki Mitsugi, Kaori Shima, Masumi Ishizuka and Hirotohi Nagata

New Technology Research Laboratories, Sumitomo Osaka Cement Co., Ltd.,  
585 Toyotomi-cho, Funabashi-shi, Chiba 274-8601 Japan

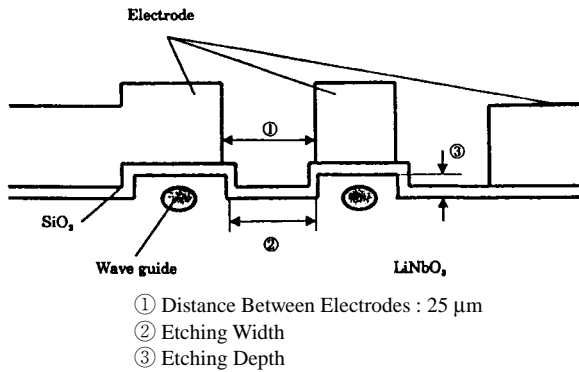
Fig.1 (a) Schematic illustration of cross section of the fabricated LN MZ optical intensity modulator having ridge waveguides.

Figure 1 shows a schematic illustration of the ridge waveguides fabricated on the z-cut LN substrate. After the Mach-Zehnder (MZ) type waveguides were formed on the substrate by a conventional Ti-diffusion technique, on both side of the MZ waveguide arms, the rectangular spaces were etched to 2.8 ~ 3.6  $\mu\text{m}$  in depth, 40  $\mu\text{m}$  in length along the waveguide and 5 or 15  $\mu\text{m}$  in width. The etched width corresponds to the gap between the obtained ridge waveguides in Fig. 1. Then, a 1.2  $\mu\text{m}$   $\text{SiO}_2$  buffer layer was deposited by rf sputtering of a  $\text{SiO}_2$  target with an  $\text{Ar}/\text{O}_2$  mixture to a thickness, and a 100 nm thick Si layer was further sputter deposited. Over the ridge waveguides covered by the  $\text{SiO}_2$  and Si layers, 17  $\mu\text{m}$  thick coplanar gold electrodes were formed by electroplating to give a 25  $\mu\text{m}$  gap between the hot and ground electrodes.
